A Preliminary Investigation on Effects of the Indian Ocean tsunami on Coastal Morphology of Indrapurwa Settlement of Aceh Besar, Indonesia

Syamsidik, Musa Al A'la, Ella Meilianda, and Teuku Muhammad Rasyif

**Tsunami and Disaster Mitigation Research Center (TDMRC)
Syiah Kuala University, Banda Aceh-INDONESIA**

Presented at the 7th South China Sea Tsunami Workshop, November 17-22,
Taichung-Taiwan

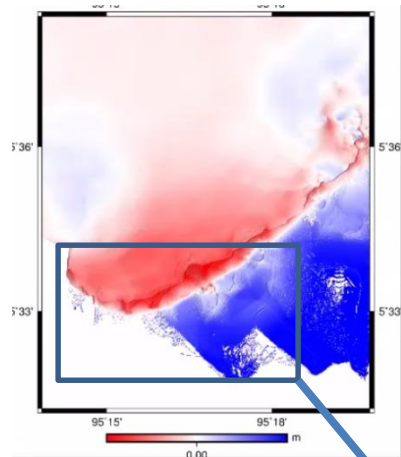
Inundation Area

Aerial image of the area after the 2004 tsunami

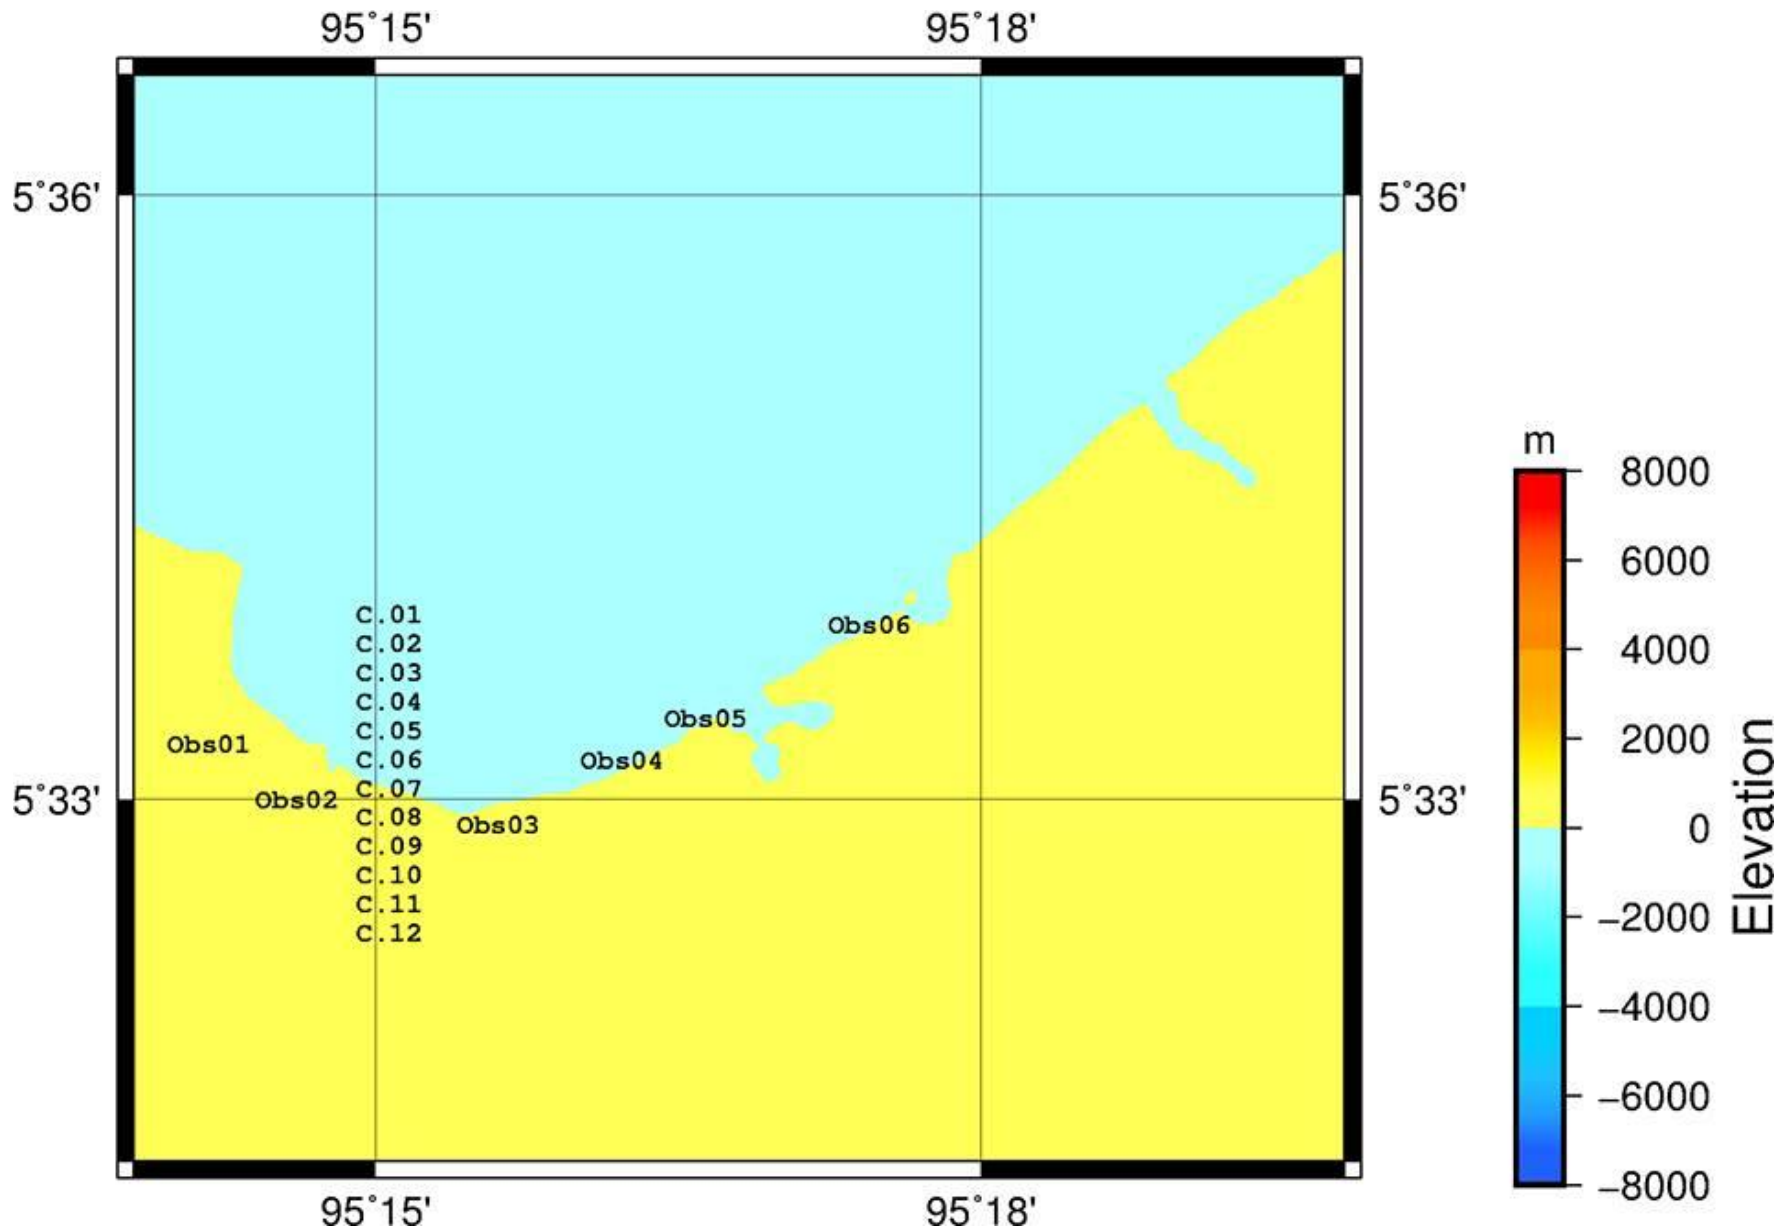
Numerical Observation Points

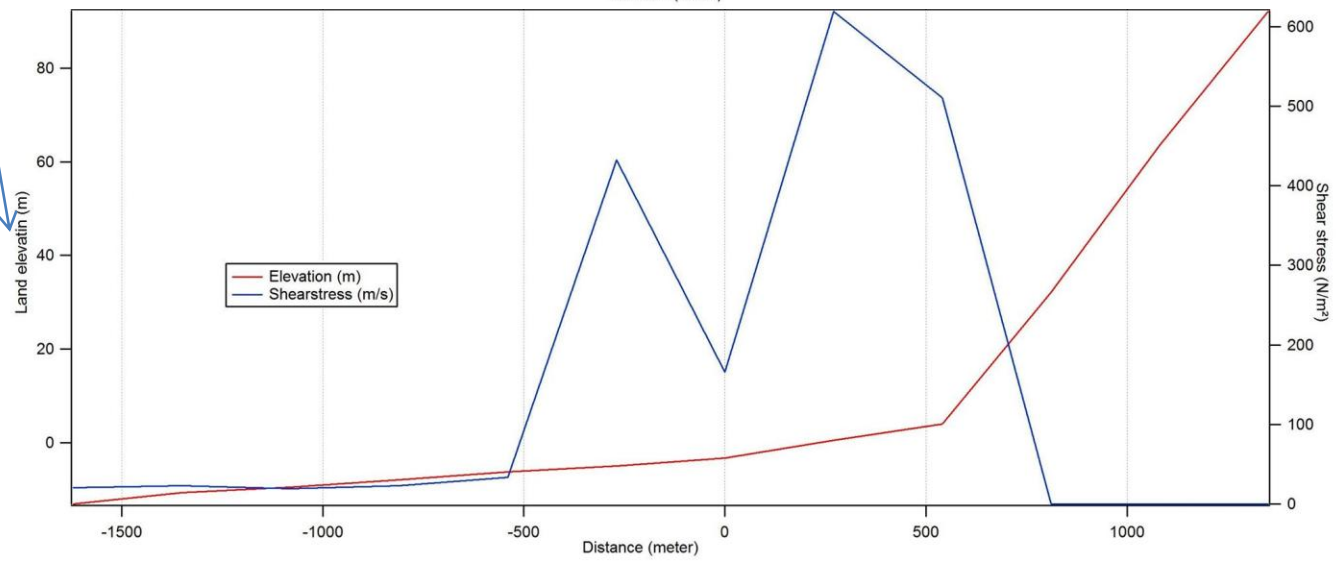
Tsunami Water Heights and Shear Stress

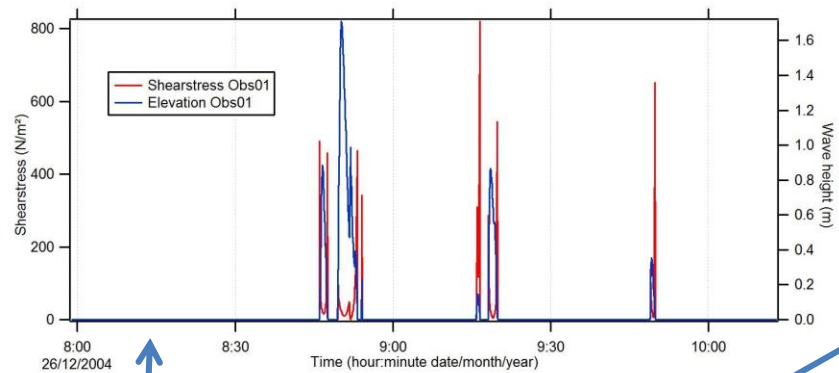
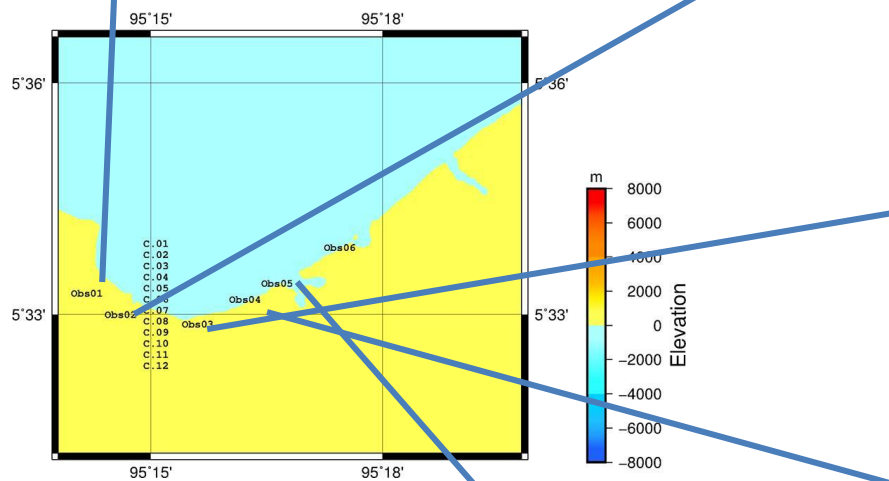
Shear Stresses at the Points

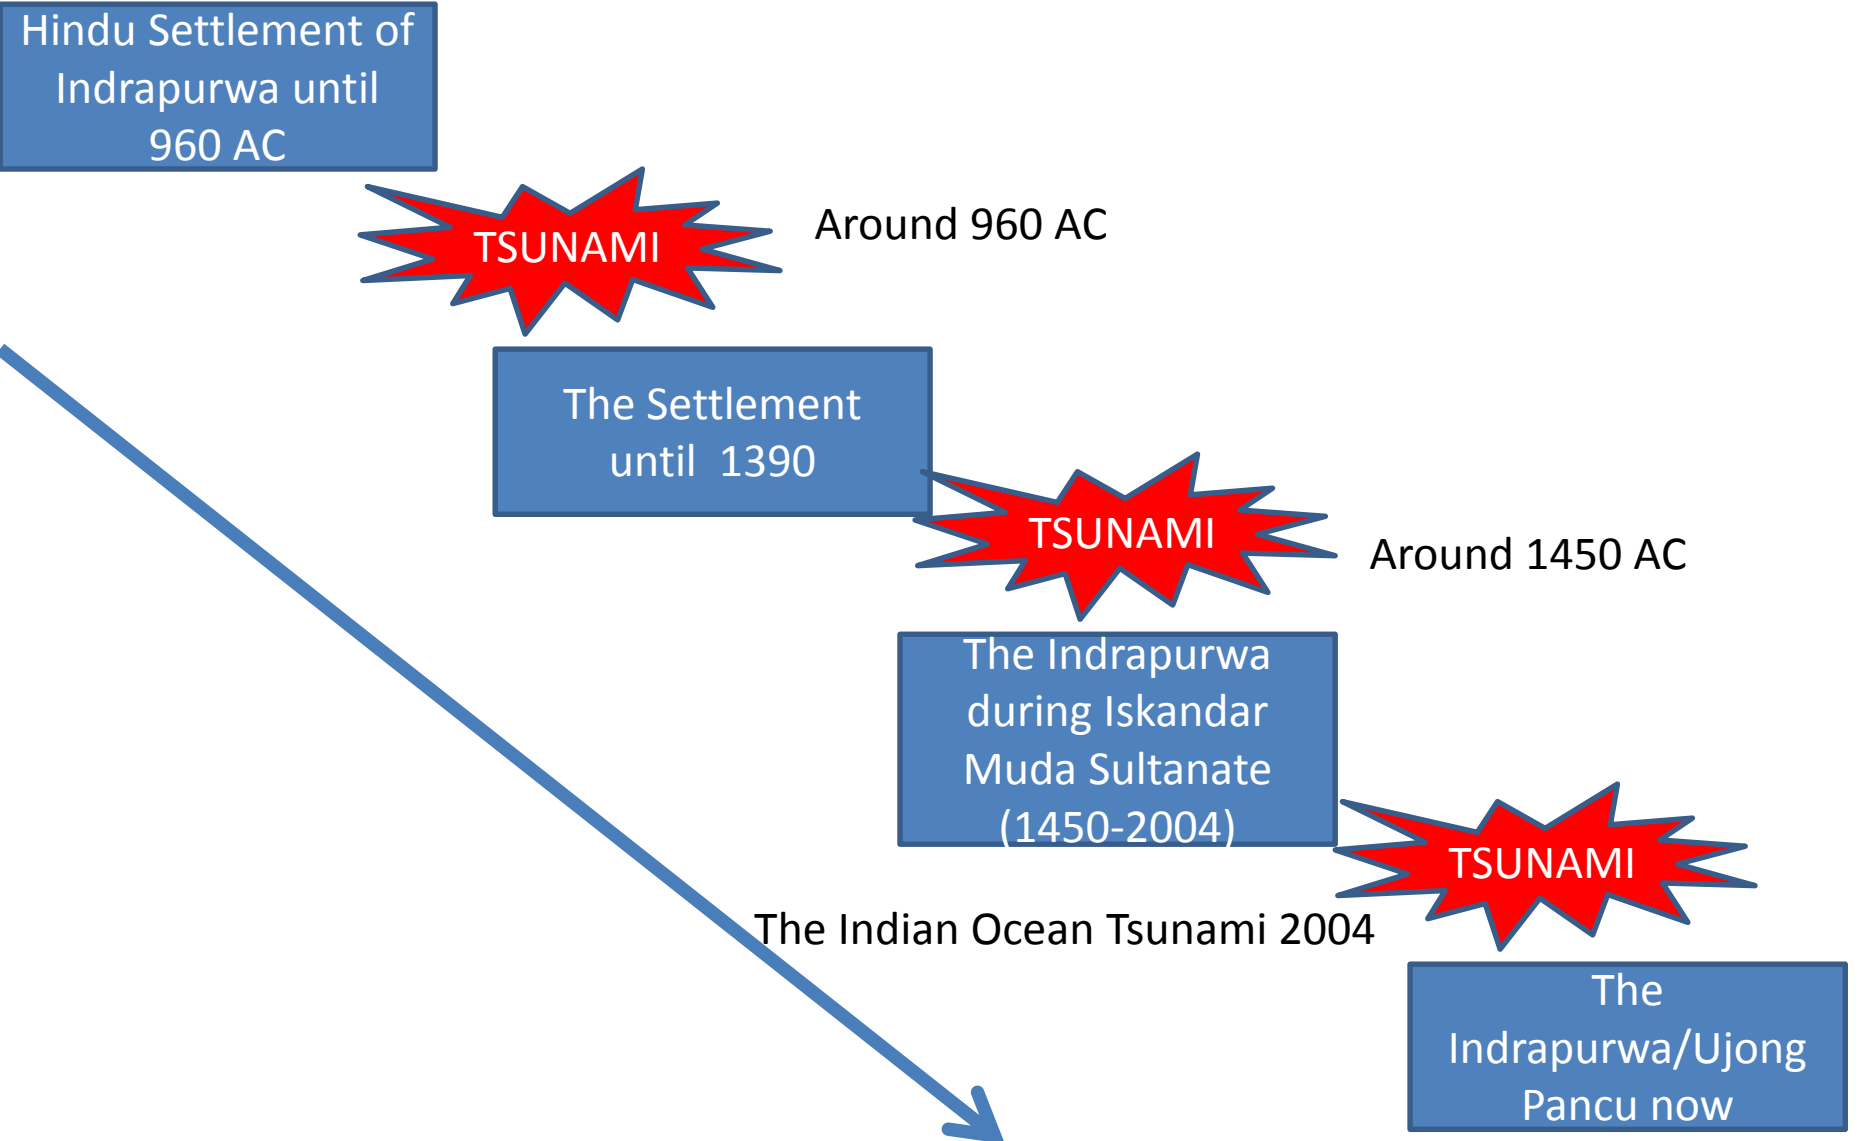
The History of the Indrapurwa Settlement

(tentative findings)
